STAND-PIPE ACCIDENTS AND FAILURES

IN THE UNITED STATES.

6-7627
A CHRONOLOGICAL RECORD OF ACCIDENTS TO AND
FAILURES OF WATER-WORKS STAND-PIPES
IN THE UNITED STATES, WITH FULL
DISCUSSIONS AND ASSIGNMENT
OF THEORIES.

WM. D. PENCE, C. E.,

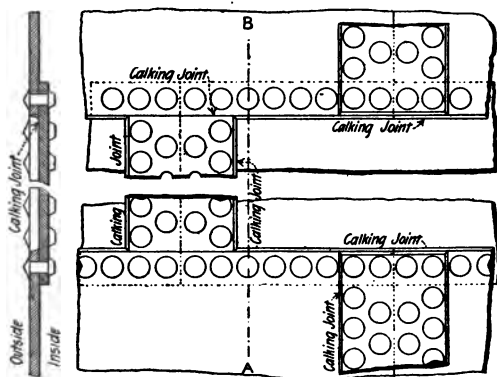
FIG. 32. METHOD OF JOINING PLATES IN STEAM-PIPES.

One is the method of joining the plates. The present method of lapping both horizontal and vertical seams is awkward and unmechanical, and belongs more to the methods of the village blacksmith than those of precise and scientific mechanism. They should rather be made like the accompanying sketch, Fig. 32, taken from a paper read by the writer before the New England Water-Works Association in 1893. In this sketch the horizontal seams are lapped and the vertical seams made with butt straps. This is a perfectly precise method, and requires no beating down or drawing out of the plates, and, in my opinion, would really cost no more than the old way. I use it now on plates over $\frac{1}{2}$ in. in thickness, but should prefer to use it on all thicknesses.

I believe that the rivet holes should be punched smaller than the rivets; a $\frac{3}{4}$ -in. hole should be punched $\frac{1}{2}$ in., and other sizes in proportion, and when the

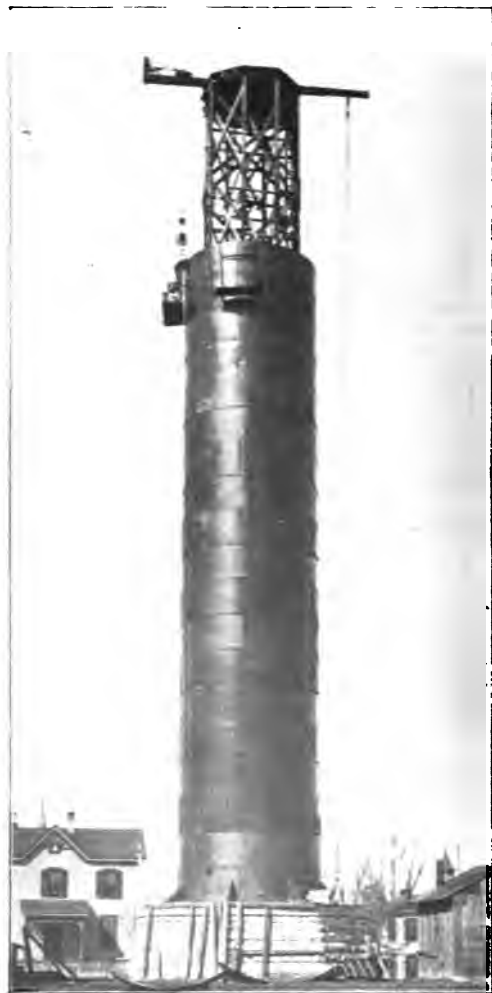
FIG. 37. STAND-PIPE UNDER CONSTRUCTION FROM INSIDE SCAFFOLDING, ST. BERNARD, O.

A noteworthy innovation in the erection of this stand-pipe was the use of a pneumatic riveting machine, which was employed throughout in riveting the shell together. The machine and the operator's platform are shown in the view, Fig. 37, as they are suspended and swung into position for work.
